Fire Safety Challenges of Tall Wood Buildings – Phase 2: Task 1 - Literature Review

Daniel Brandon and Birgit Östman

SP Technical Research Institute of Sweden
Stockholm, Sweden

September 2016

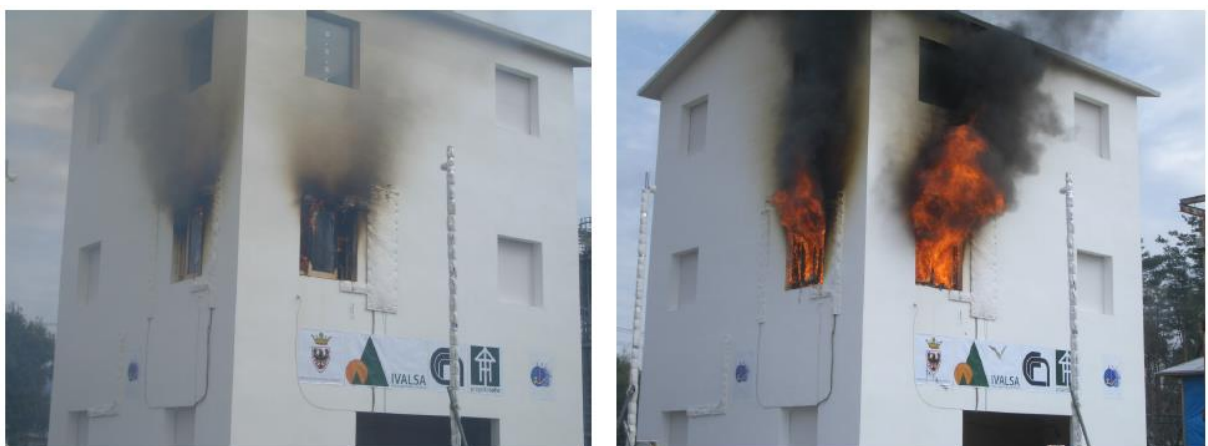
The results showed a rapid increase of gas temperatures in the first 10 minutes and after approximately 35 minutes. The latter was caused by the failure of the single layer of standard gypsum board protection that was applied on the thickest CLT wall. Increased flaming outside of the apartment confirmed an increased intensity (Figure 3). Temperatures behind the two layers of gypsum plaster board rapidly increased at approximately 50 minutes after ignition. The results suggested that the insulation behind the gypsum boards fell off almost immediately after the gypsum board failed. Decay of the fire was observed after approximately 55 minutes and the fire was manually extinguished after 60 minutes. The windows of the upper floor did not fail and there was no fire and smoke spread to the upper floor.

Figure 3: Fire after 32 minutes (left) and 40 minutes (right)

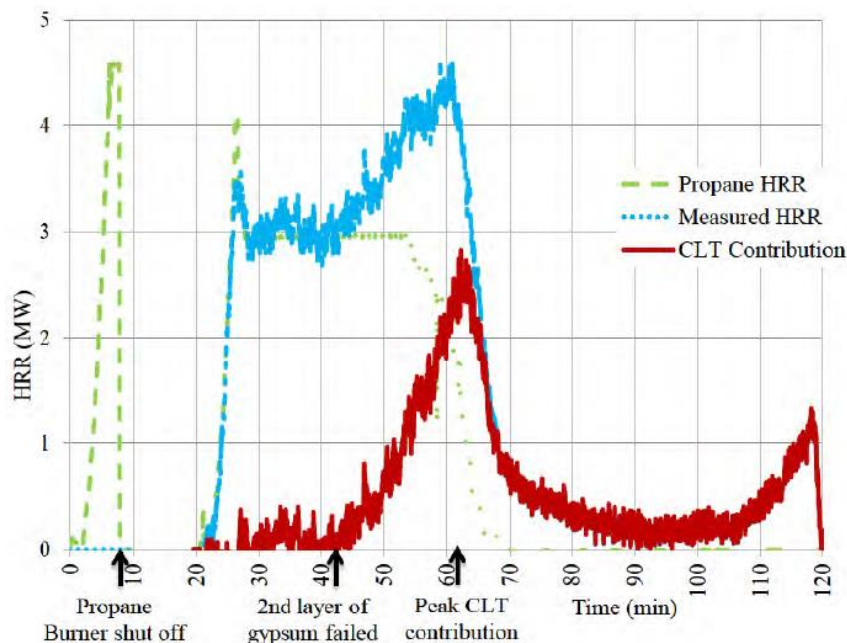
In McGregor's propane fueled fire tests the propane flow was controlled and the heat release rate corresponding to propane was calculated. The contribution of the CLT to the heat release rate was then calculated by excluding the heat release rate corresponding to propane from the measured heat release rate (Figure 6 and 7). In one of the propane fueled tests, test I1, the CLT was protected using 2 layers of 12.7mm fire rated gypsum board. The remaining test, test I3, comprised of directly exposed CLT.

Figure 6: Heat release rate corresponding to propane, the measured heat release rate and the air velocity of the extracted air (test I1), from McGregor (2013)

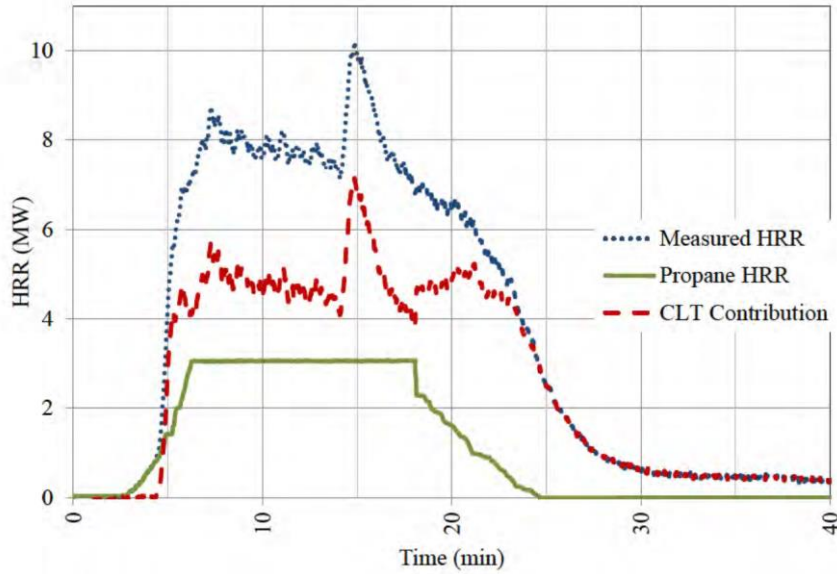
Figure 7: Heat release rate corresponding to propane, the measured heat release rate and the contribution of CLT (test I3), from McGregor (2013)

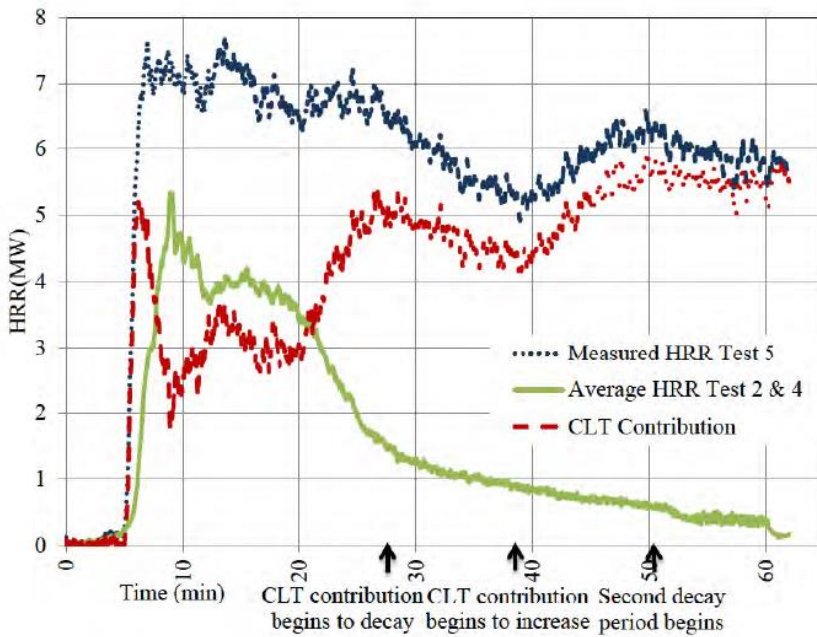
McGregor also performed three furniture fueled tests of which two comprised fully protected CLT and one comprised unprotected CLT. By assuming that fully protected CLT does not contribute to a compartment fire, the heat release rate and temperature increase corresponding to timber could be determined (Figure 8). This assumption was confirmed using the results of the propane fueled test. Table 5 gives an overview of the estimated heat released corresponding to the movable fire load and the CLT.

Figure 8: The CLT contribution derived from HRR results of test I5, I2 and I4, from McGregor (2013)

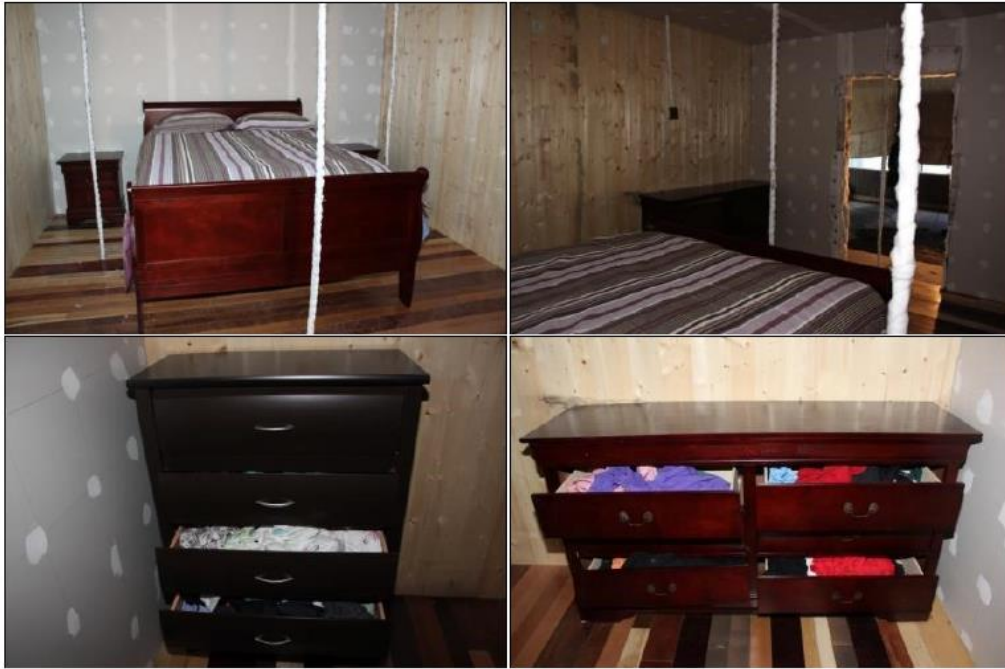
Figure 9: Interior of Test K3, from Medina Hevia (2014)

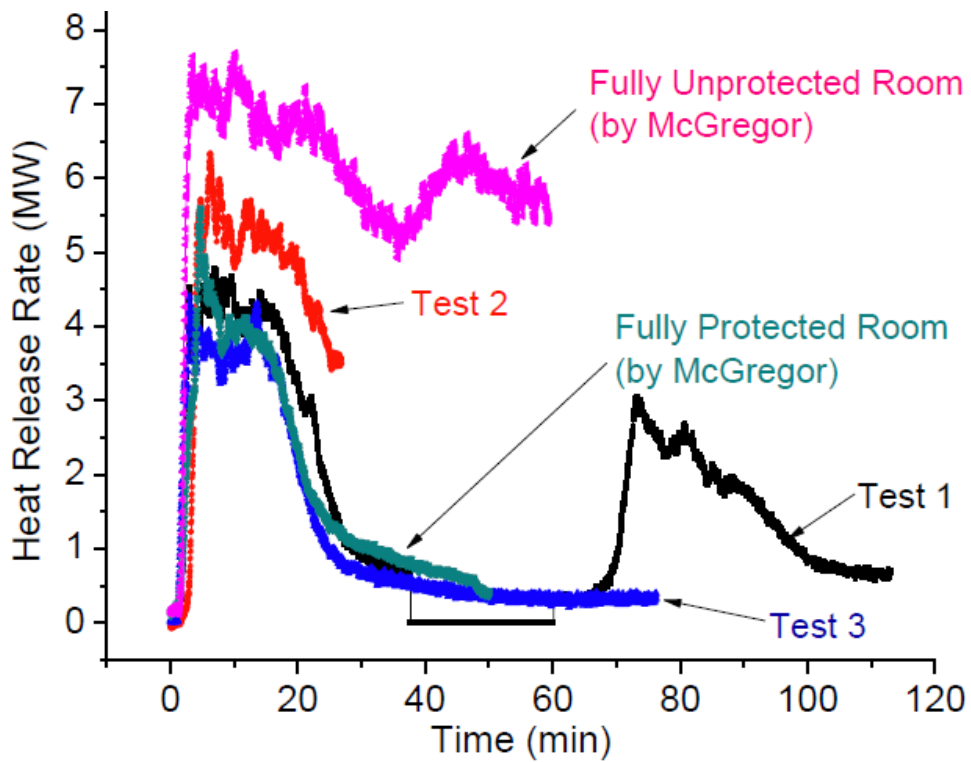
It was concluded that unprotected CLT contributes to the fire growth rate, the intensity and the duration of the fire and that the contributions are generally more significant if more surface is exposed. Medina Hevia demonstrated that the fire tested compartment comprising one unprotected wall, accounting for 29.7 % of total room wall area, performed similarly to a fully protected compartment and resulted in self-extinguishment after the room contents were consumed. The compartments comprising two exposed walls showed delamination of CLT lamellas, which resulted in second flashovers. It was found that two opposing walls that were unprotected led to higher heat release rates than two adjacent walls. Furthermore, it was concluded by McGregor that CLT protected by two 12.7mm layers of fire rated gypsum plaster board did not noticeably contribute to the duration or intensity of compartment fires if fall-off of gypsum did not occur. Once the gypsum board failed, the CLT increased the intensity of the fire and a second flashover occurred. In the same way delamination of the CLT has led to a second flash over.

Figure 10: Comparisons between HRR corresponding to test K1, K2, K3 and test I2 (fully protected) and I5 (unprotected)

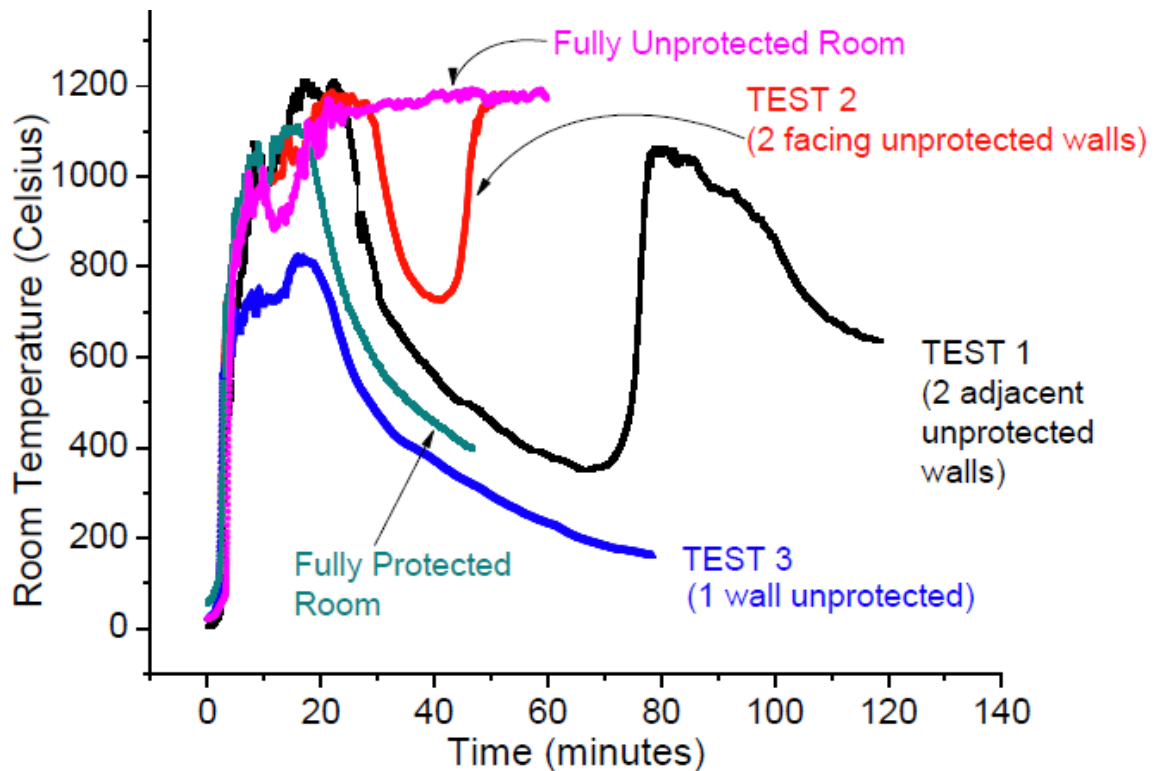
In the early stages of the fire the room temperatures were similar for all tests. Exposed CLT seemed to delay the temperature drop or decay of the fire.

Figure 11: Comparisons between temperatures corresponding to test K1, K2, K3 and test I2 (fully protected) and I5 (unprotected)

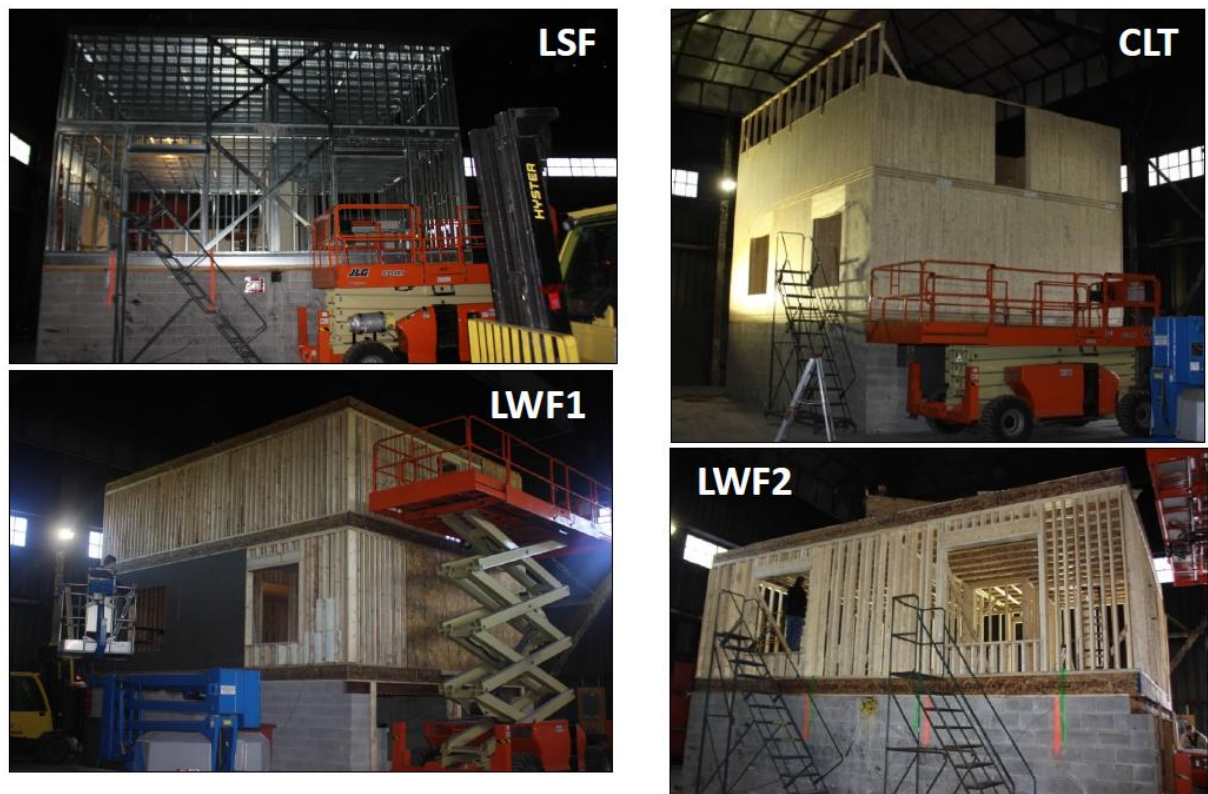
The light weight timber frame apartments of tests L1 and L4 were constructed from closely spaced studs and a 15.9mm OSB panel as a shear layer on one side (the least vulnerable side of the walls). Glass fiber insulation was applied in all timber frames and two layers of gypsum board were applied on both sides of the walls. The Floor and ceiling were constructed using I joists with a depth of 241mm and 15.9mm OSB subfloor sheathing. The ceiling comprised of two layers of 12.7mm type X gypsum board that protected the I joists. At locations where the walls met the I joist floor, the layers of gypsum board were interrupted. Glass fiber insulation was applied in the ceiling and the floors.

Figure 14: Compartments of test L1 (LWF1), L2 (CLT), L3 (LSF) and L4 (LWF2) under construction, from Su and Lougheed (2014)

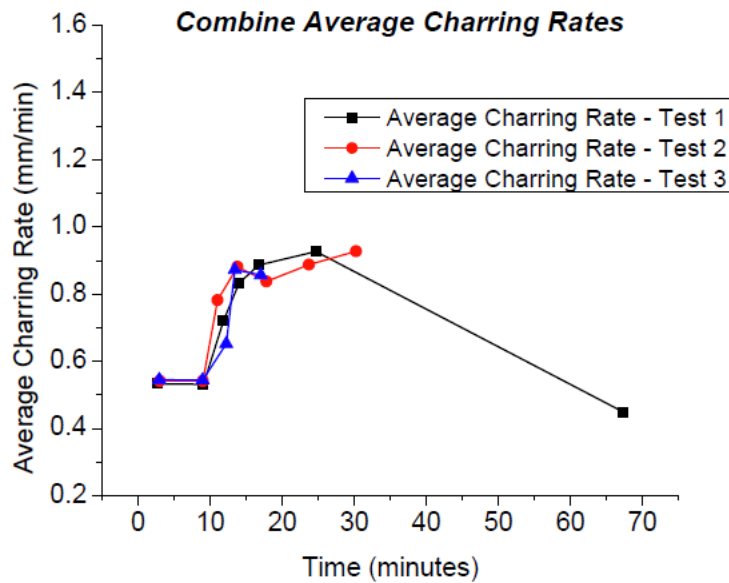
Medina Hevia (2014) conducted tests in which only one or two walls were exposed. Test K1, K2 and K3 had 63%, 58% and 79% of the CLT protected, respectively. However, the charring rates corresponding to the different tests were very similar (Figure 17).

Figure 17: Charring rates in unprotected walls of test K1, K2 and K3, from Medina Hevia (2014)
